PORT ANGELES HARBOR WOOD WASTE STUDY PORT ANGELES, WASHINGTON

FINAL

February 5, 1999

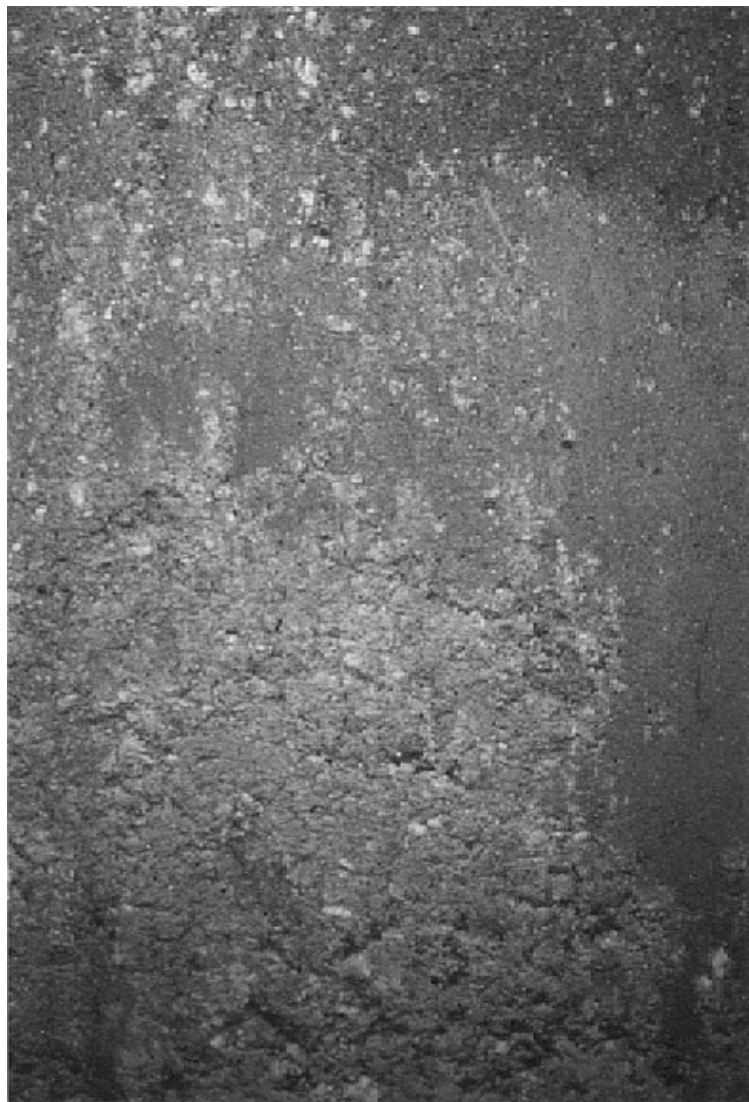
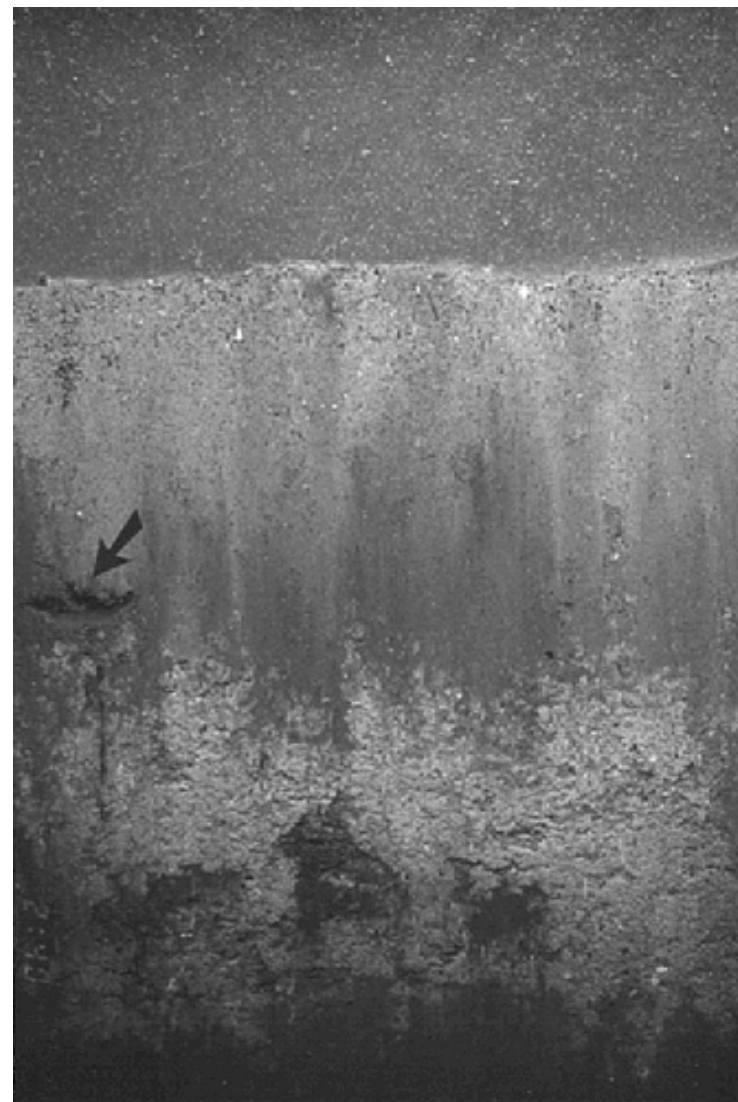
At stations 30, 45, 51, 52, and 57 in the western central portion of Port Angeles Harbor, a layer of wood pulp was found buried under 6 to 8 cm of ambient silt (Figure 7). The wood pulp layer measures from 5.1 cm thick at station 57 to >10.1 cm at station 45, and covers an area of approximately 35 acres (see Figure 6). Assuming a conservative thickness of 5.1 cm, the wood pulp layer represents approximately 9,500 cubic yards of wood pulp. However, the subsurface layer of wood pulp does not appear to have adverse impacts to the benthic infaunal community. The profile images at these locations show well-developed RPD depths and feeding voids in the overlying ambient silt layer, and the presence of polychaetes within the wood pulp layer (Figure 7, image 52/B).

Figure 7. SVPS images from stations 91 (replicate A) and 52/B in Port Angeles Harbor. Station 91 is located near the Daishowa loading dock and shows abundant wood pulp accumulation greater than camera prism penetration. Overpenetration indicates high water content and a high sedimentation rate. Silt is mixed into the upper portions of the wood fabric. Station 52 located in the western central portion of the harbor shows a wood pulp layer (5.2 cm) buried under 7.9 cm of ambient sediment. A feeding void (arrow) is present and a polychaete is feeding within the wood pulp layer.

A layer of wood pulp was found buried under 6 to 8 cm of ambient silt in the western central harbor (Figures 6 and 7). The subsurface wood pulp deposit covers an area of approximately 35 acres. Very little sediment is mixed within the pulp layer, suggesting that the wood pulp was deposited very rapidly on the harbor bottom. One possible explanation could be that barges loaded with wood pulp may have listed during a storm and lost their loads. Assuming a conservative thickness of 5.1 cm, the buried wood pulp layer represents approximately 9,500 cubic yards of wood pulp.

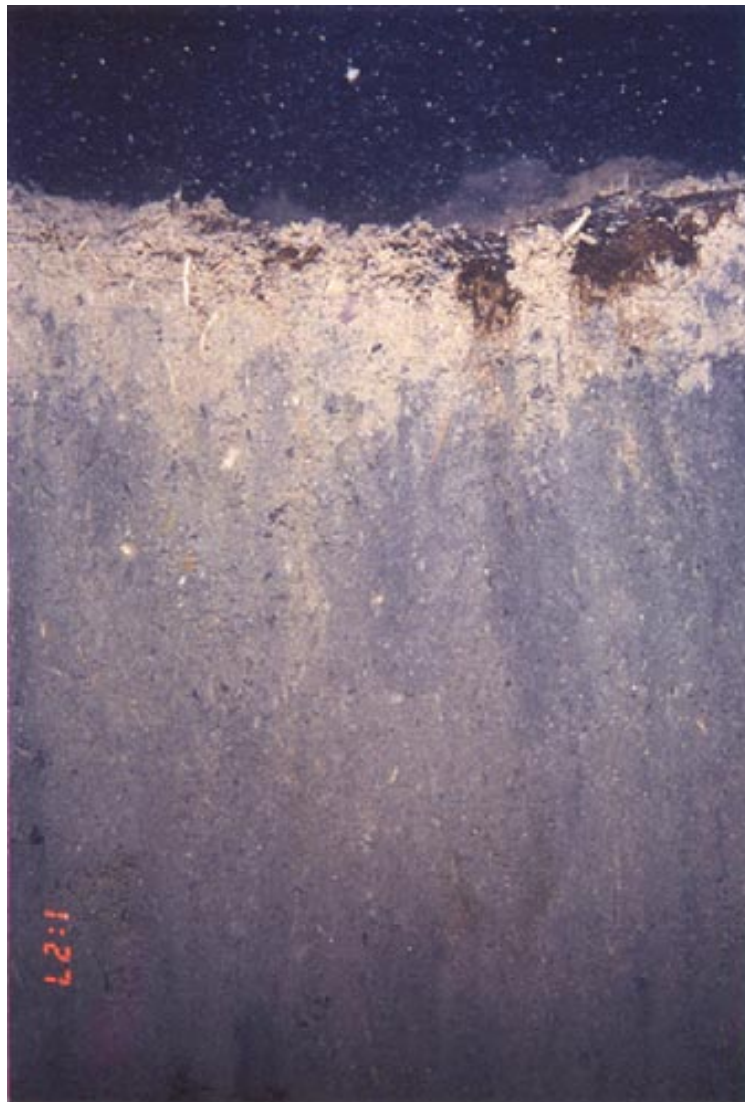
At three stations (19, 63, and 67) along the southwest shoreline, possible creosote and/or oil was observed in the SVPS images.

SVPS images from stations 63/B and 69/A in Port Angeles Harbor. Station 63 located near the K-Ply wood chip loading dock shows fine wood particles (pulp) mixed within the sediment column. The image shows a well-developed apparent RPD depth (3.56 cm) and a filamentous red/brown algae (bacterial mats?) is present on the sediment surface. Station 69 located along the western pier-face of the former ITT Rayonier facility also shows wood pulp mixed within the sediment column. Two methane bubbles are present within relic feeding voids (arrows) which indicates degraded sediment conditions and potential for high sediment oxygen demand.

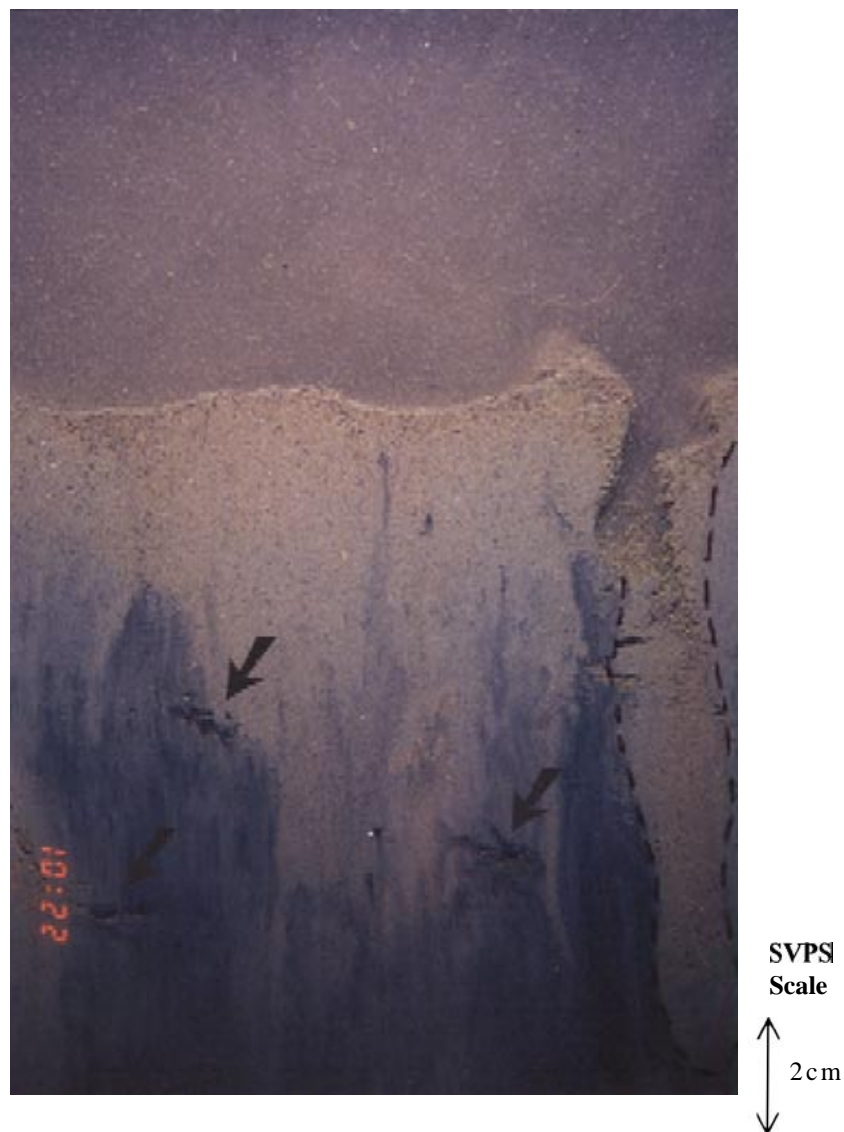
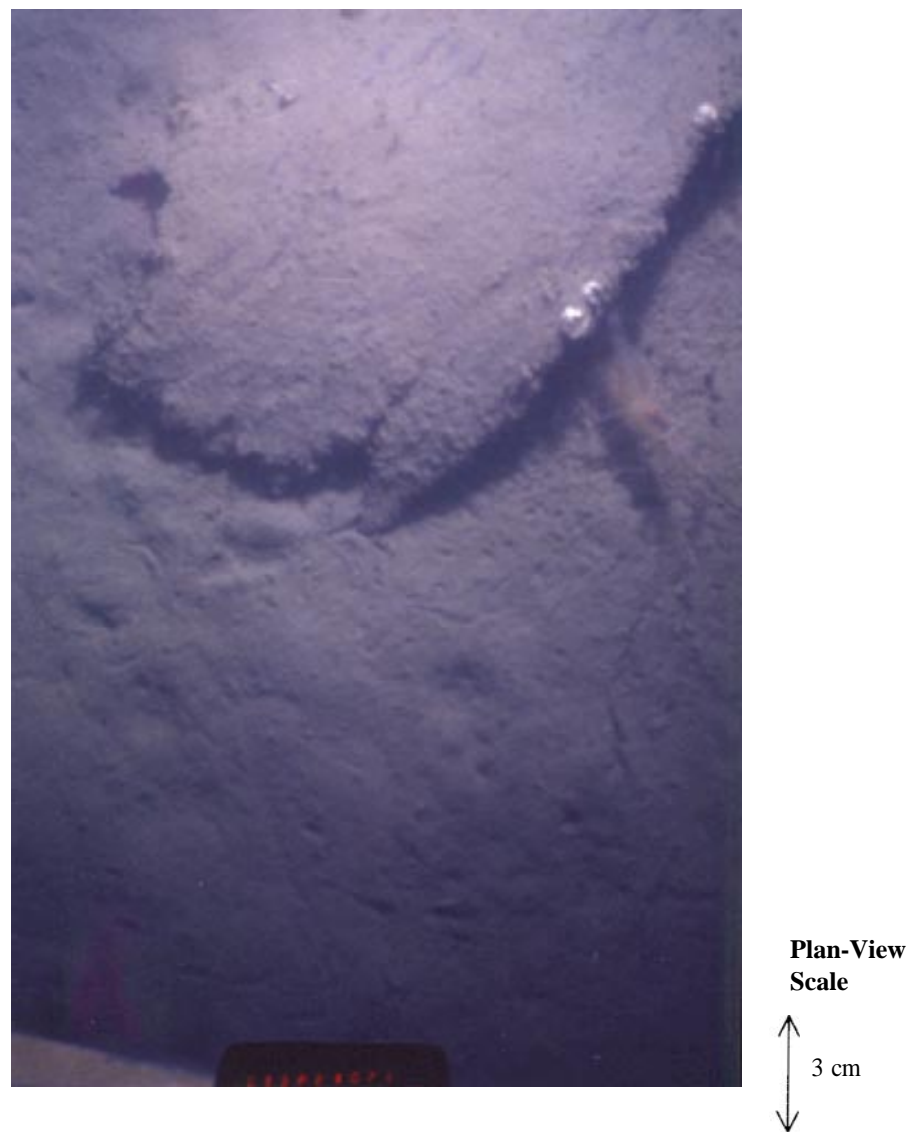
Figure 9. SVPS and plan-view images from station 6 (north-central part of the harbor) where sparse, scattered wood debris is present on the sediment surface. The SVPS image shows healthy sediment conditions. A well-developed apparent RPD depth, feeding voids (arrows), and a possible anemone burrow are present (dotted line delimits the burrow). The plan-view image shows a piece of wood debris on the sediment surface with a shrimp seeking shelter beneath the wood debris.

18 shows a crab (*Cancer*) and small fish (goby?) at station 77, where sparse wood debris was observed on the sediment surface. Figure 9 shows a plan-view image at station 6 with a shrimp seeking shelter below a piece of wood debris. Similarly, a coon-striped shrimp (*Pandalus danae*) is sitting on a stick on the harbor bottom at station 47 (report cover). As long as overlying water quality is not impacted, wood debris can provide habitat for epibenthic organisms.

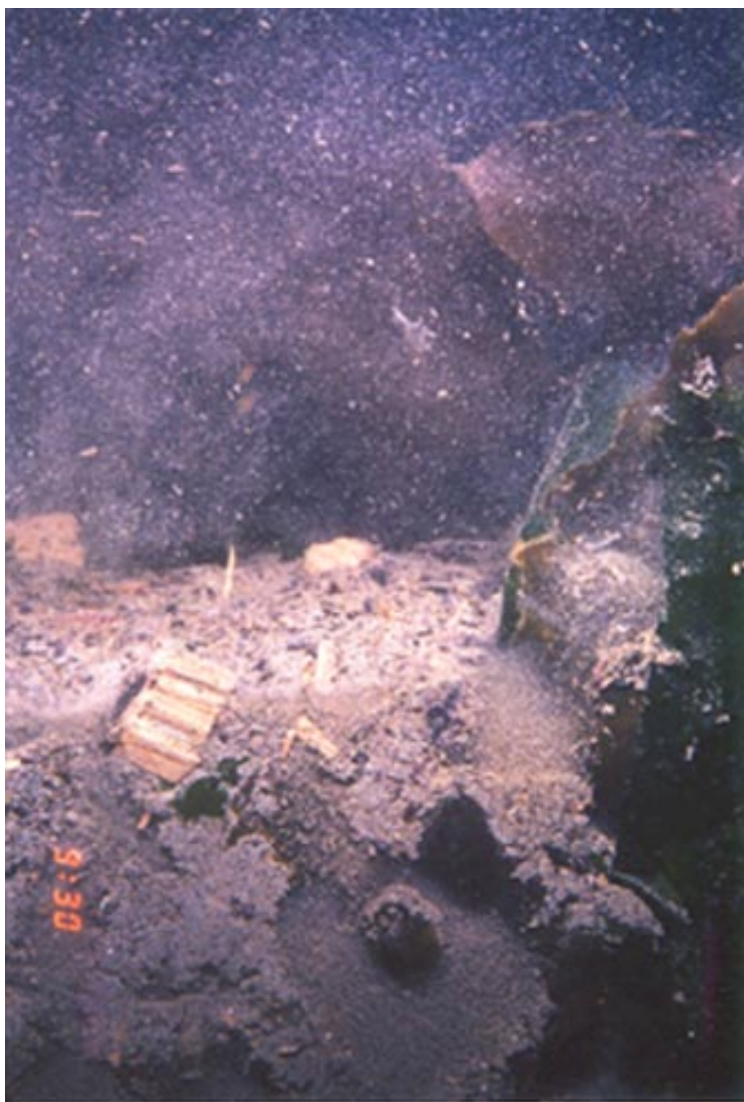
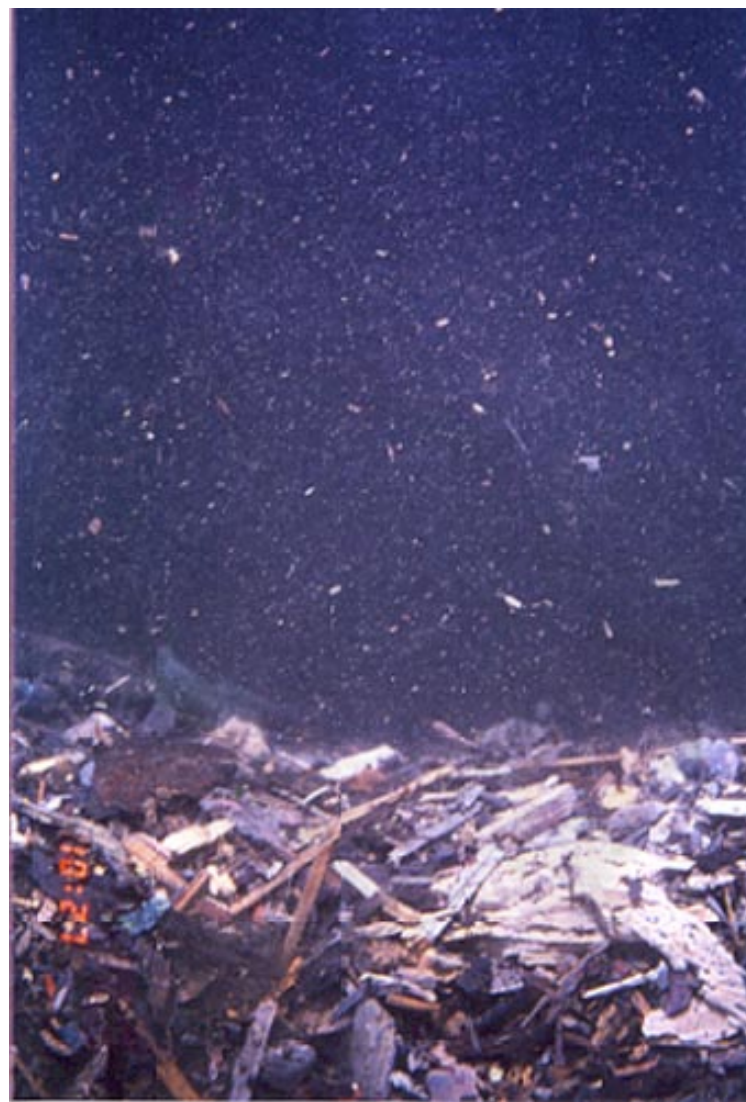
The greatest accumulation of wood waste was observed in the north and west portions of the harbor, in the active log booming grounds and near the Daishowa facility (Figure 6). This area covers approximately 400 acres (0.6 square miles) of harbor bottom. Wood waste consisted of discreet wood/pulp layers, wood pulp mixed within the sediment column (MX), and scattered wood pieces on the sediment surface (SC). The highest measurable amount of wood waste was at station 91 (next to Daishowa), where >21 cm of wood pulp accumulation was measured (Figure 7). Profile and plan-view images showing “MX” and “SC” wood waste conditions are provided in Figures 8 and 9. Wood waste was also identified near the log dumping grounds (approximately 30 acres) and the former ITT Rayonier booming grounds (approximately 55 acres). Abundant wood chip accumulations were measured at stations 23 and 94 near the ITT Rayonier facility (Figure 10).

Figure 10. SVPS images from stations 23/C and 94/C in the log booming grounds near the former ITT Rayonier facility. Station 23 shows abundant wood chips and fibers mixed in the surface sediments. Green algae (*Ulva* and/or *Enteromorpha*) on the right side of the image has been dragged down into the sediment by the camera prism. Station 94 shows a pile of wood chips and fragments (>7.8 cm). Underlying sediments are not visible in the image.

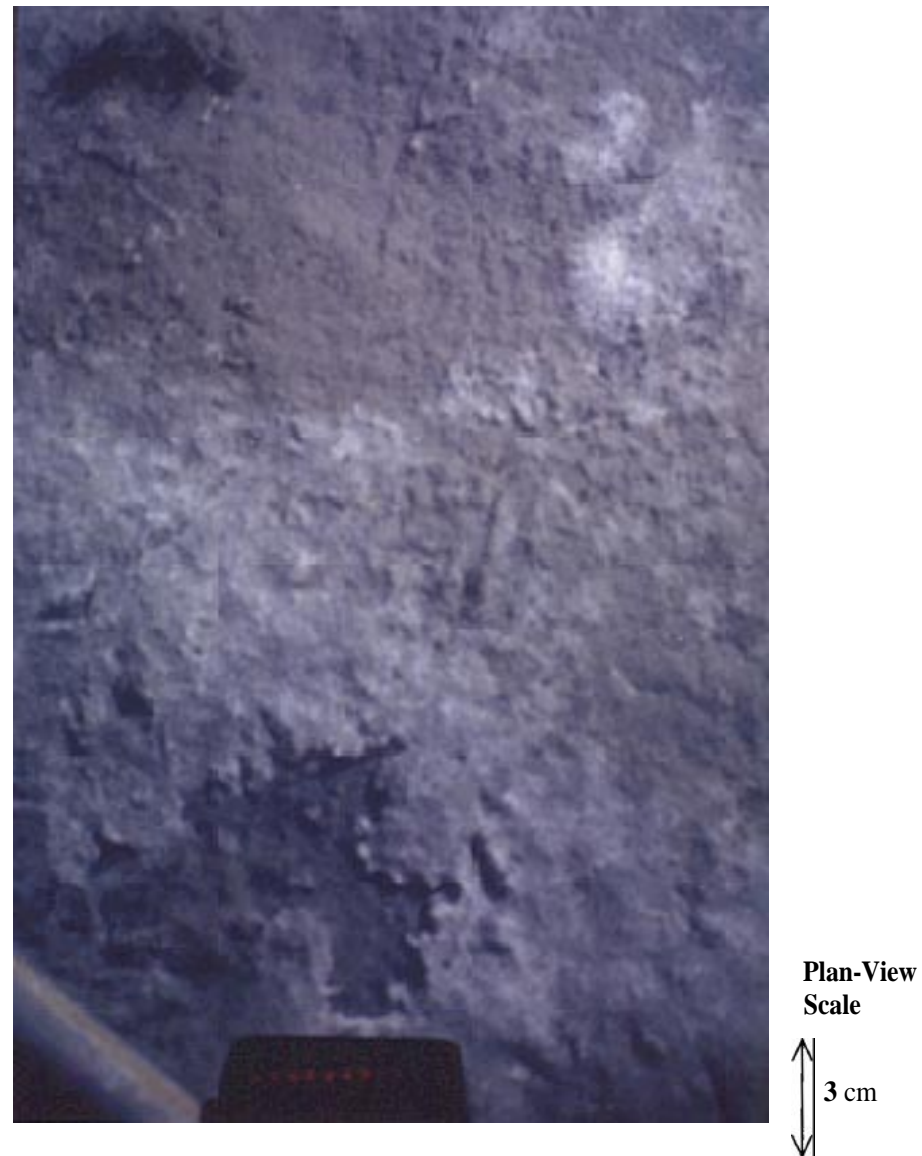
At stations 9, 12, 38, and 39, where a thin layer of wood pulp was measured at the sediment surface, the presence and growth of sulfur-reducing bacteria has created a membrane or bacterial mat (Figures 11 and 12). Presence of bacterial mats is indicative of high labile organic carbon and low dissolved oxygen conditions (see discussion in Section 5.3).

Figure 11. SVPS and plan-view images from station 9 (in log booming grounds in north-central part of the harbor) showing the presence of a wood fiber layer. Dense populations of sulfate-reducing bacteria have created a “bacterial mat” or membrane on the sediment surface (white fibrous material in the SVPS and plan-view images). Formation of these bacterial mats occurs in anaerobic conditions. Sediments underlying the bacterial mat (approximately 3.7 cm thick) are black and sulfidic.

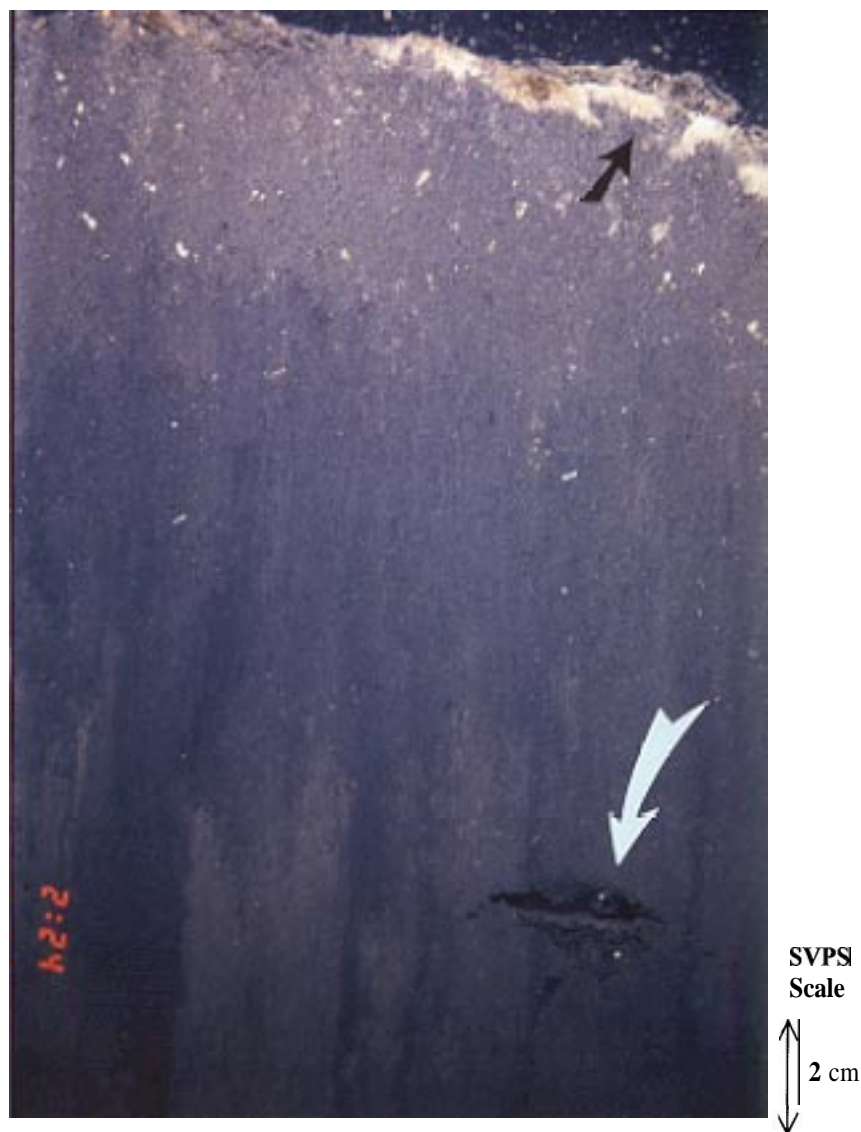
Figure 12.

SVPS and plan-view images from station 12 (in log booming grounds just east of Daishowa) showing the presence of a wood fiber layer. Dense populations of sulfate-reducing bacteria have created a thin "bacterial mat" or membrane on the sediment surface (white fibrous material in the SVPS image). Notice the ventral "fringes" of filaments in the bacterial mats (black arrow). A methane bubble is also present at depth in a relic feeding void (white arrow). The bacterial mat surface has high sediment oxygen demand. As the bacteria use up sulfate, sedimentary methane can accumulate. The plan-view image shows the fibrous, membrane-like appearance of the bacterial mat. The bulb-like features on the surface may be fusiform rods related to a different type of bacterial growth.

Accumulations of fine wood particles (i.e., pulp, wood chips) in low energy environments causes organic enrichment, leading to degradation of benthic habitat and potentially to a decline in the overlying water quality. This process appears to be occurring at some stations along the western shoreline of the harbor (see Figure 15). Bacterial mats were observed at stations 9, 12, 38 and 39, which indicate high labile organic loading and low dissolved oxygen conditions (Figure 11 and 12). Dense populations of sulfate-reducing bacteria can populate wood pulp deposits. This “fiber blanket” surface has a high SOD and a thin or non-existent apparent RPD depth within the sediment column. When sulfate is used up, methane gas may then accumulate within the bottom sediments (observed as bubbles in SVPS images). A methane bubble is present in a relict feeding void at station 12 (see Figure 12).

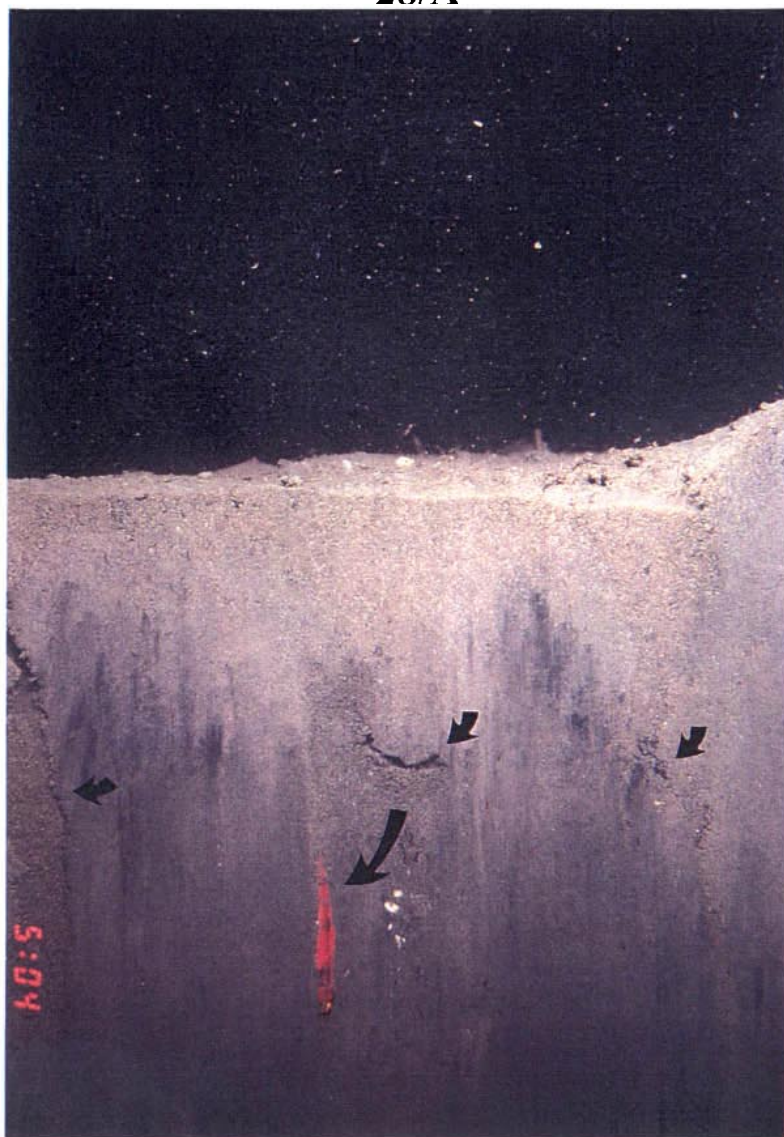
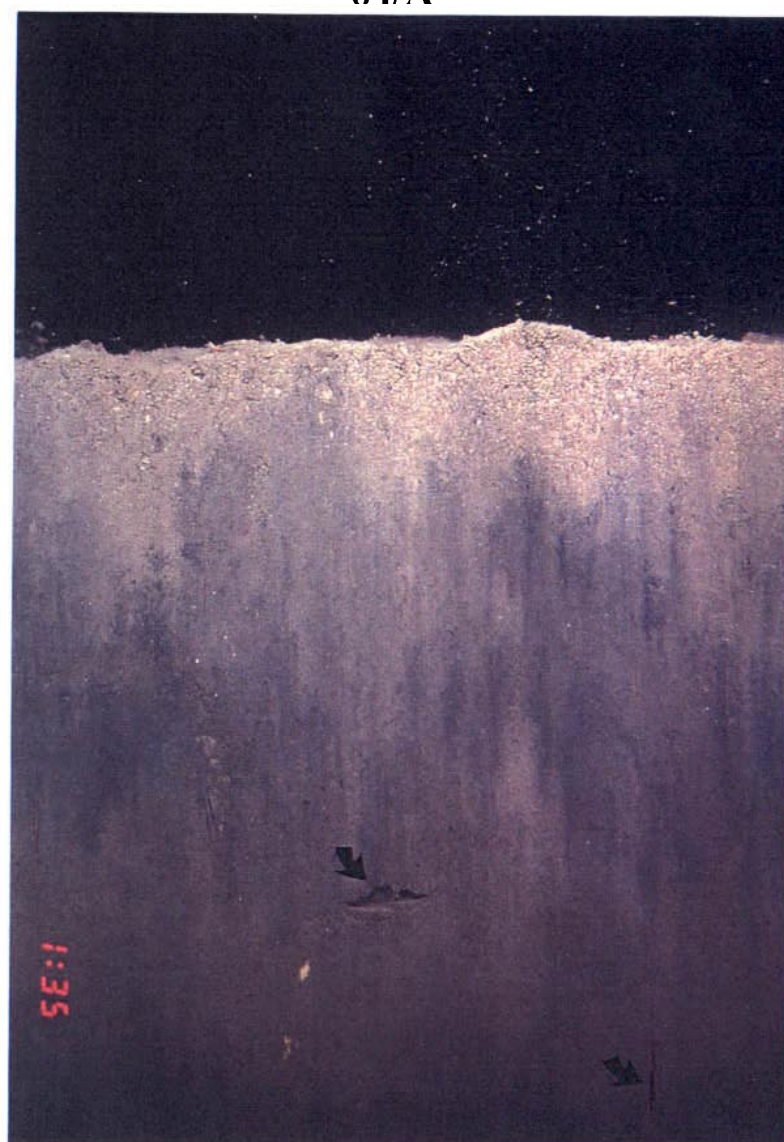
Figure 14. SVPS images from stations 28/A and 64/A in the central harbor showing minimal pulp impact. Station 28 shows Stage I tube worms on the sediment surface and a polychaete worm at depth (large arrow). Stage III feeding voids and a possible burrow (small arrows) are present as well as a deep apparent RPD (3.22 cm). Station 64 provides a good reference for undisturbed bottom conditions in Port Angeles Harbor. The image shows a well-developed apparent RPD depth and the presence of a Stage III feeding void and polychaete (arrows) at depth.

Areas of the harbor bottom with no apparent wood debris have healthy sediment conditions with epibenthic organisms present on the sediment surface (Figures 14 and 18). Figure 18 shows a small flat fish present at the sediment surface at station 35 (central outer harbor). The underlying sediments have well-developed apparent RPD depths, and Stage III infaunal communities are present.
